RESEARCH ARTICLE

Experimental study on corrosion resistance of coiled tubing welds in high temperature and pressure environment

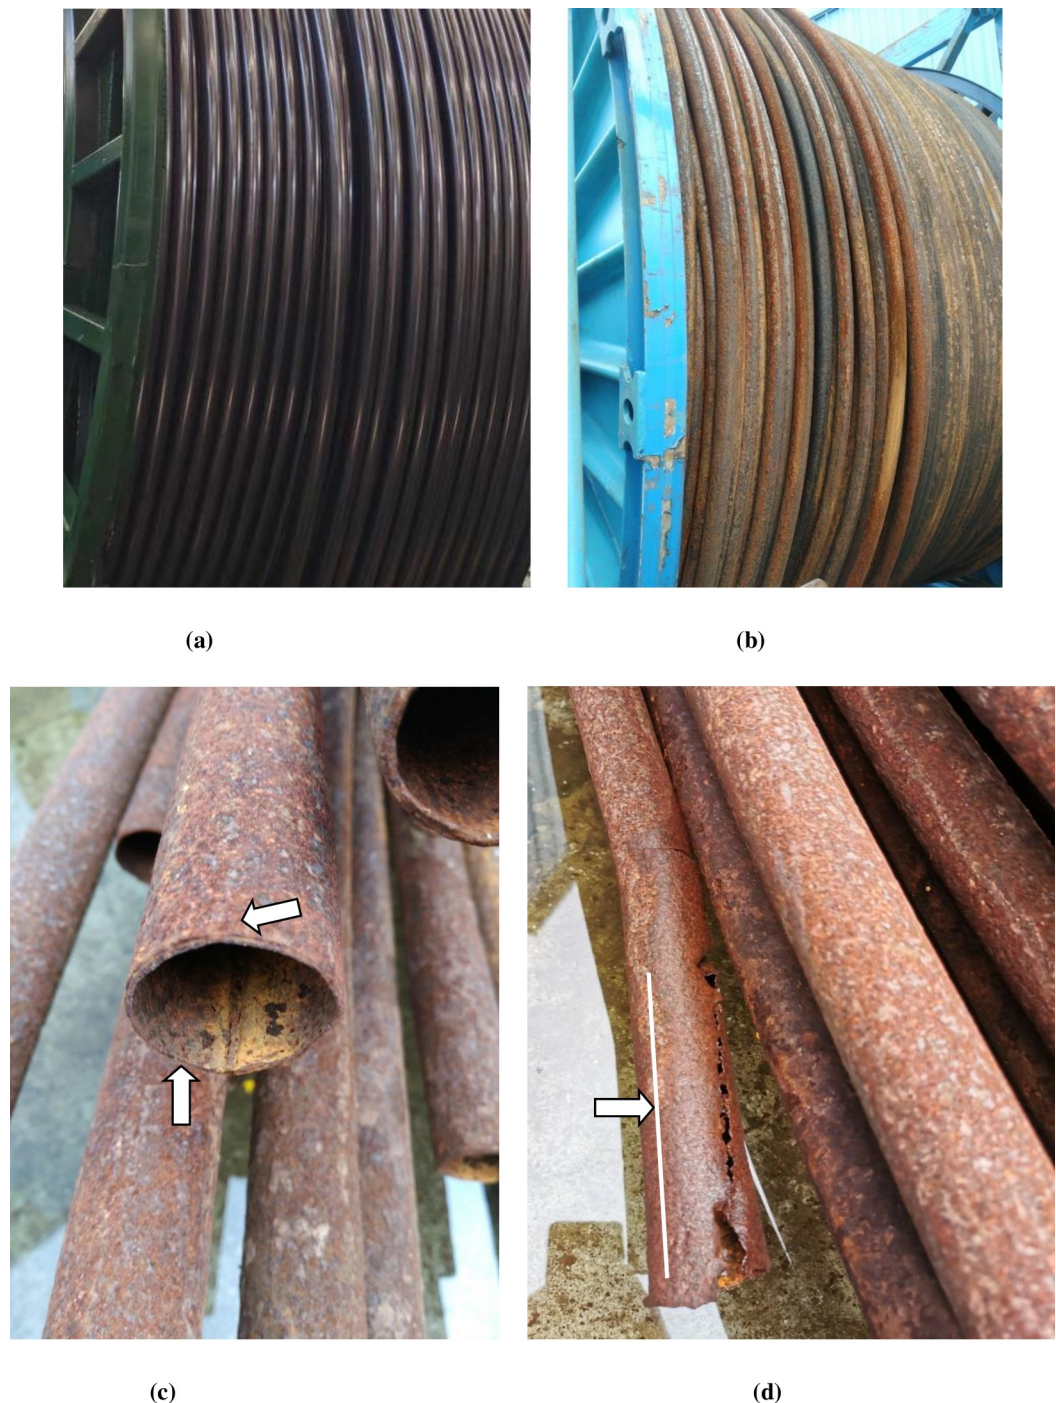
Fig 1. Corrosion morphology of CT after operation in Marine environment. (a) A new CT (not used), (b) After use CT, (c) Appearance of CT after corrosion, (d) Corrosion cracking along the weld.

S1 Fig. Corrosion morphology of CT after operation in Marine environment. (a) A new CT (not used), (b) After use CT, (c) Appearance of CT after corrosion, (d) Corrosion cracking along the weld.

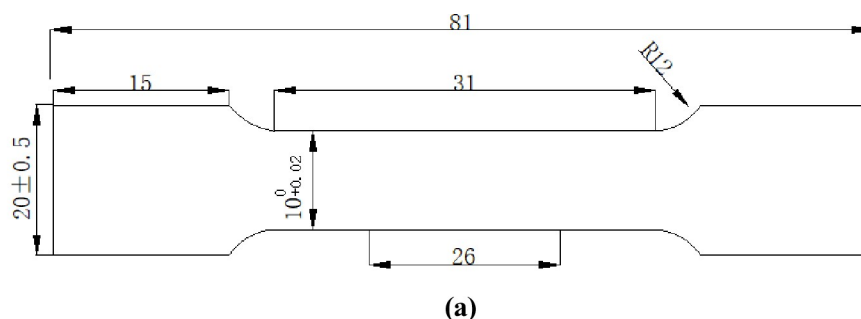
(b) Physical drawing of cutting locations of samples

Fig 2. Sample figure. (a)Standard tensile specimen dimension and (b) Physical drawing of cutting position of sample.

Samples made of CT110 were used in the experiment, with an outer diameter of 50.8mm and a wall thickness of 4.4mm. The samples are defined as weld metal samples (WM) and base metal samples (BM), with their main chemical compositions shown in Table 1. According to GB/T228-2002 national standard for tensile test specimen, the standard specimen with the dimension of 81mm×20mm×2mm [22] was processed by wire cutting out of WM and BM after forming, as shown in Fig 2(A). The WM samples were cut along the axis direction of the weld seam, and the CT weld line was arranged to align with the middle of the samples. The actual cutting locations of the sample were shown in Fig 2(B). The surfaces of the processed samples were polished and treated with 600[#], 800[#] and 1200[#] water sandpaper successively, and final CT110 WM and BM samples were shown in Fig 3.

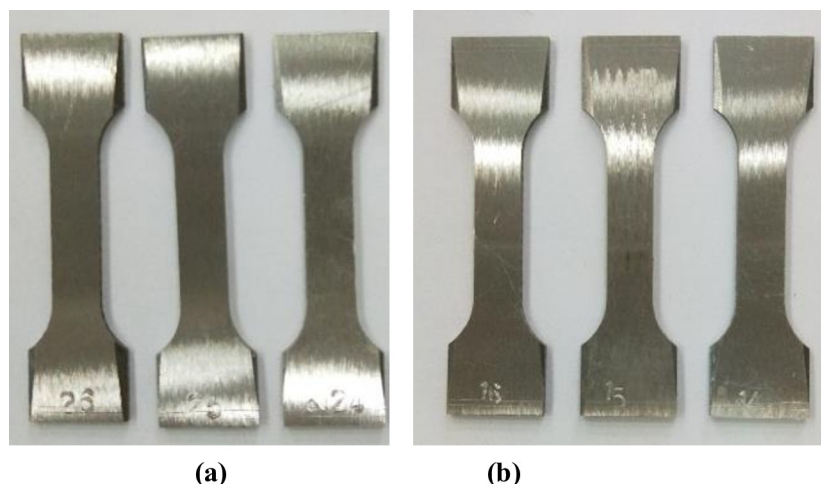
Fig 3. Standard tensile test samples of the WM and BM of CT. (a) WM, (b) BM.

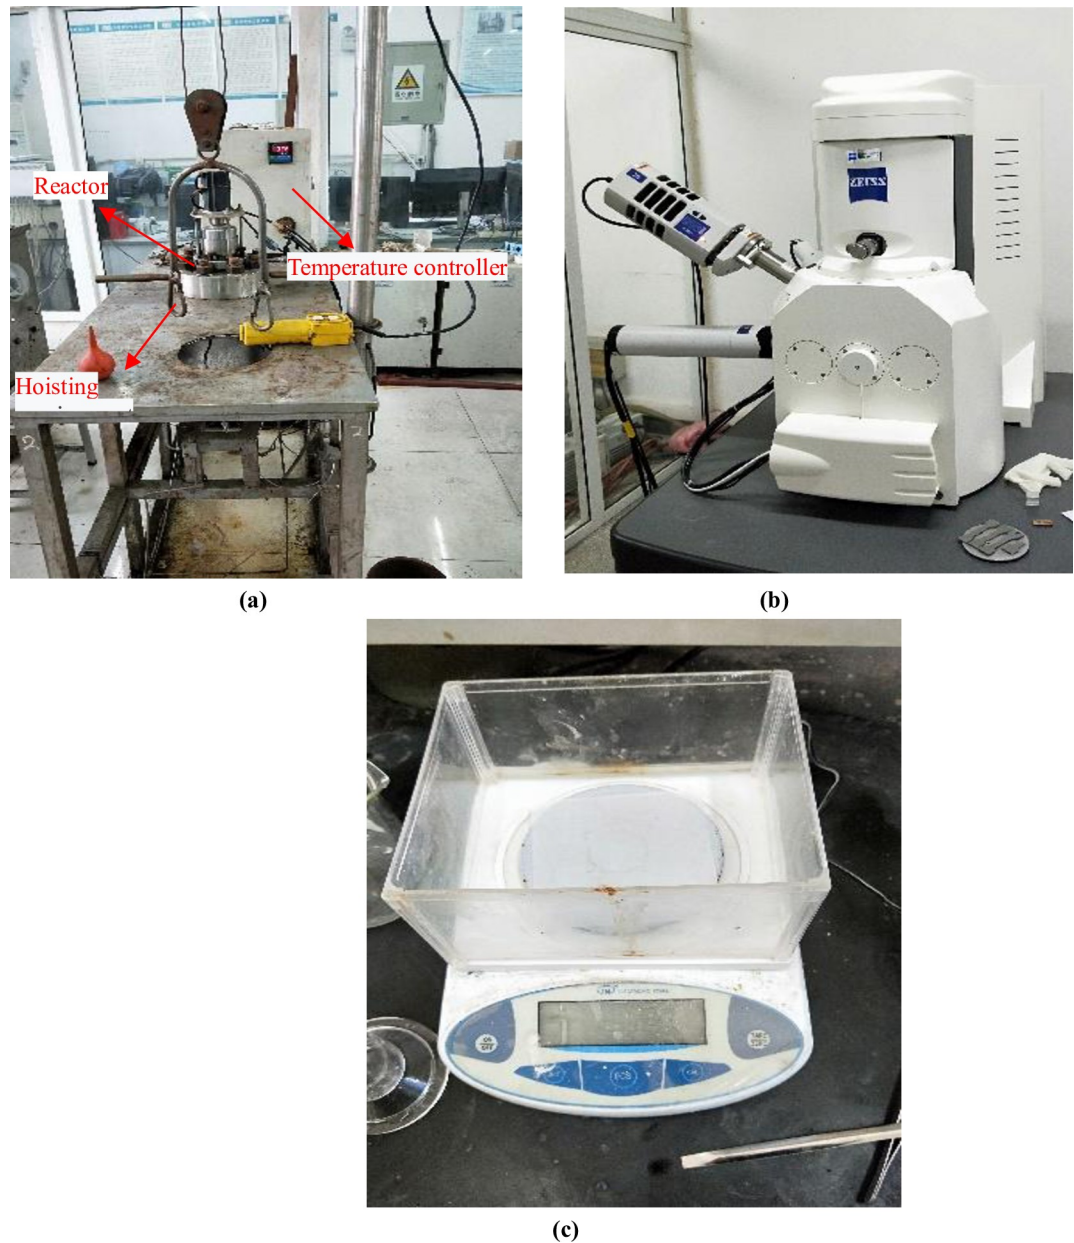
Fig 4. Main instruments of the experiment. (a) High-temperature and high-pressure reactor, (b) Scanning electron microscope and (c) Electronic balance.

During the experiment, the sample were hanged on the support with nylon wires and loaded into the high-temperature and high-pressure reactor (as shown in Fig 4(A), and the prepared

experimental reagent was poured in, so that the sample in the reactor became fully soaked, then closed the reactor to start following test procedure: A pressure test was conducted in the reactor to ensure that all the seals were intact, and N_2 was aerated to purge oxygen out of the reactor for 2 hours. Then adjusted the temperature to simulate the designed downhole conditions, injected CO_2 to boost the pressure to the required level, and adjusted the total pressure to 4MPa. After all conditions were met started time recording and turned off the corrosion cycle in 96 hours. After releasing the reactor pressure and temperature to room conditions, took out the corroded sample, put it on the drying plate and wait to dry, visully checked the micro morphologies of the corrosion products on the surface of the CT samples through scanning electron microscope (as shown in Fig 4(B)), and analyzed the element content with the matching EDS apparatus. Finally, put it in the plate to dry again, then weigh it on the electronic balance (as shown in Fig 4(C)).

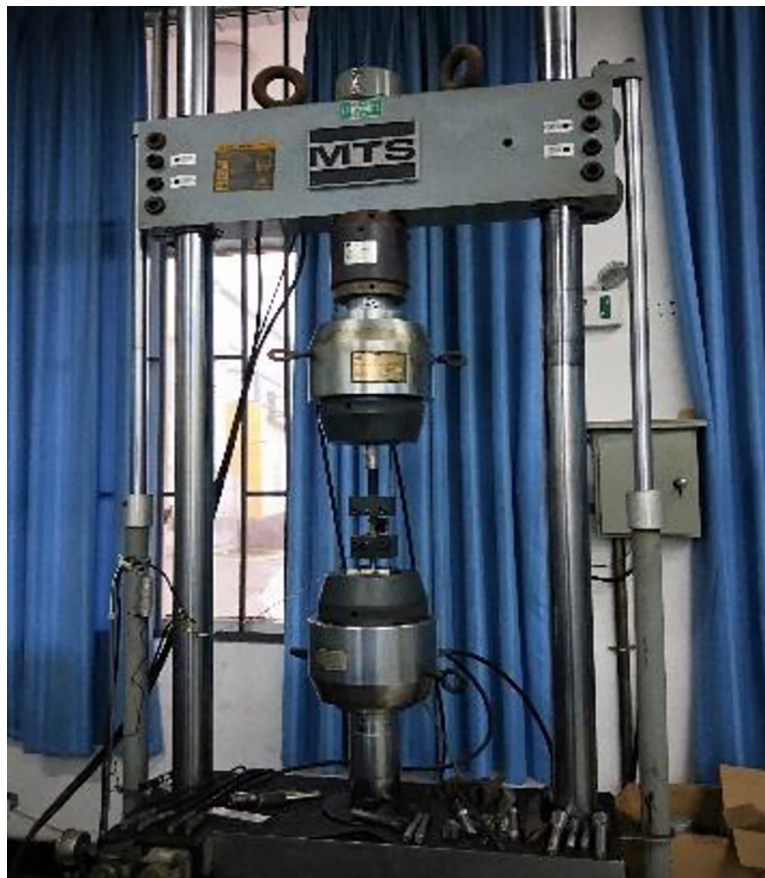
Fig 5. MTS hydraulic universal testing machine.

The MTS hydraulic universal testing machine (as shown in Fig 5) was used for tensile mechanical property test. According to API value rule [25], the stress-strain curve of the sample was drawn, and the yield strength, tensile strength and fracture elongation of the sample before and after corrosion were obtained. Then the mechanical property parameters of the WM and BM before and after corrosion were compared and analyzed against each. The yield strength was corresponding to 0.2% of the strain value, the tensile strength was the maximum stress before the plastic strain, and the fracture elongation was the strain value when the material broke.

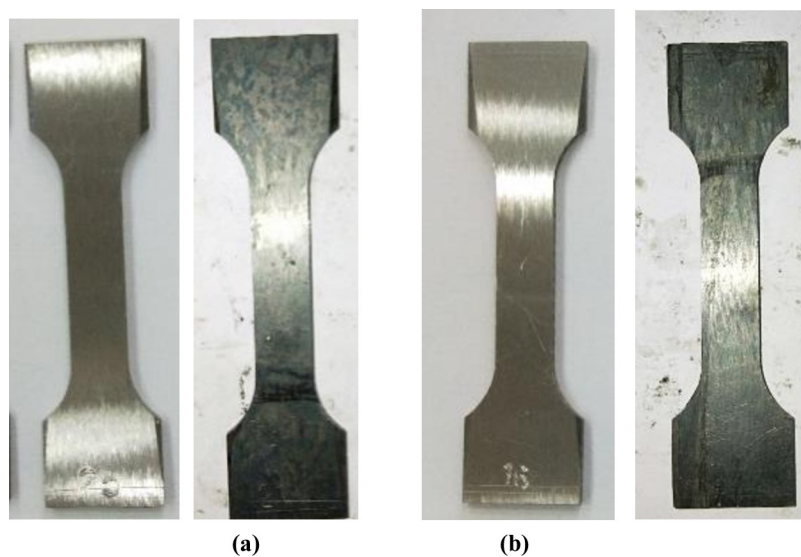
Fig 6. Comparison of macromorphology of sample surface before and after corrosion. (a) WM morphology and (b) BM morphology before and after corrosion.

Fig 6 was a comparison of macro morphology of WM and BM before and after corrosion. It can be seen from the figure that the surface of WM and BM sample were silvery white before corrosion, with bright color and smooth surface. After corrosion, the surface of the whole sample became gray and black, the metallic luster was dim, and some areas showed pitting. Through the comparison of the morphologies of WM and BM before and after corrosion, it can be seen that, the surface of BM was much smoother, and a lot of corrosion pits initiated on WM surface, which indicated that the corrosion of WM was more serious than that of BM.

S6 Fig. Comparison of macromorphology of sample surface before and after corrosion. (a) WM morphology and (b) BM morphology before and after corrosion.

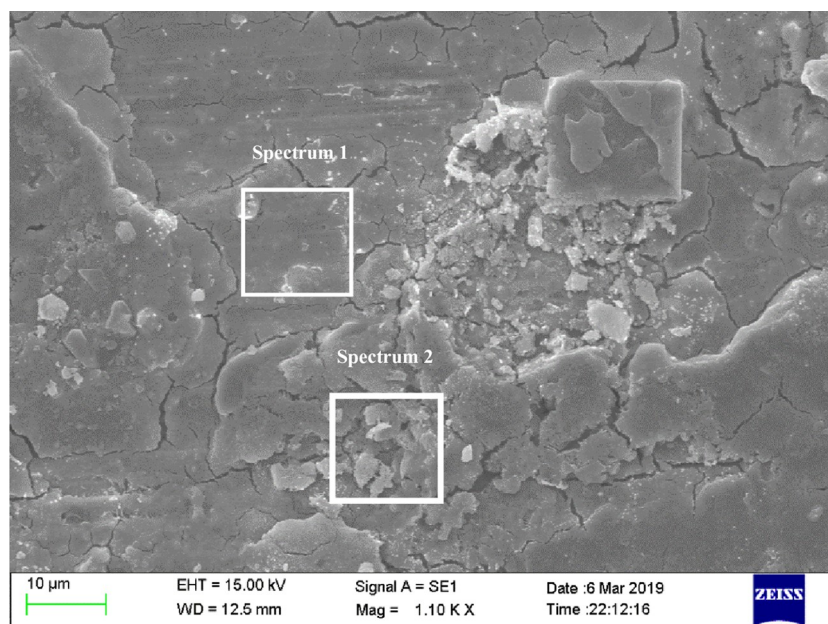
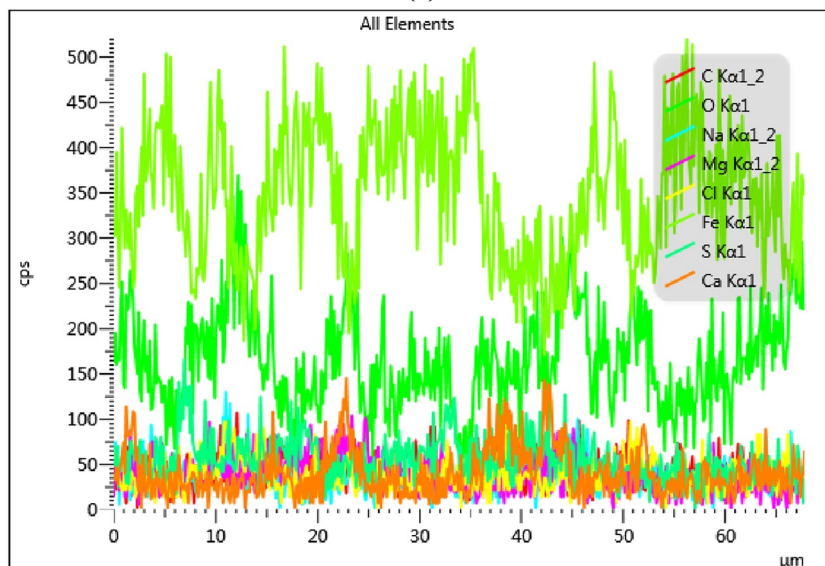
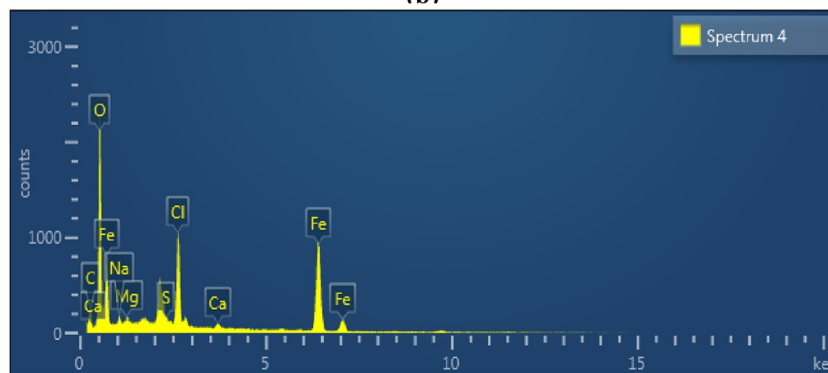
Fig 7. The micro morphology of sample surface and EDS region energy spectrum analysis diagram after BM corrosion. (a) Surface micro corrosion morphology, (b) Line scan of corrosion product elements on the surface and (c) Distribution of corrosion products on the surface.

Figs 7 and 8 were the surface micro morphologies and energy spectrum analysis diagram of BM and WM samples after corrosion, respectively. It can be seen from the micrograph after BM corrosion that there were less corrosion products on the surface of BM, and the corrosion product film in some surface areas had broken. It can be seen from the micrograph after WM corrosion that the WM surface were covered by a thicker layer of corrosion products, and most of the corrosion products film were broken, even falling off. It can be seen from the energy spectrum analysis diagram and element content table after the corrosion of BM and WM (as shown in Table 3), the compositions of the BM and WM corrosion products were

S7 Fig. The micro morphology of sample surface and EDS region energy spectrum analysis diagram after BM corrosion. (a) Surface micro corrosion morphology, (b) Line scan of corrosion product elements on the surface and (c) Distribution of corrosion products on the surface.

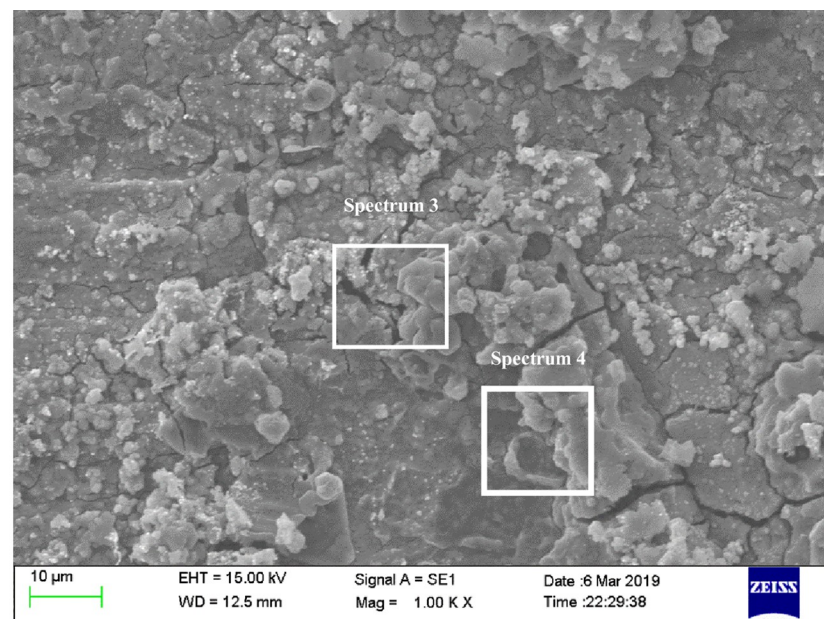
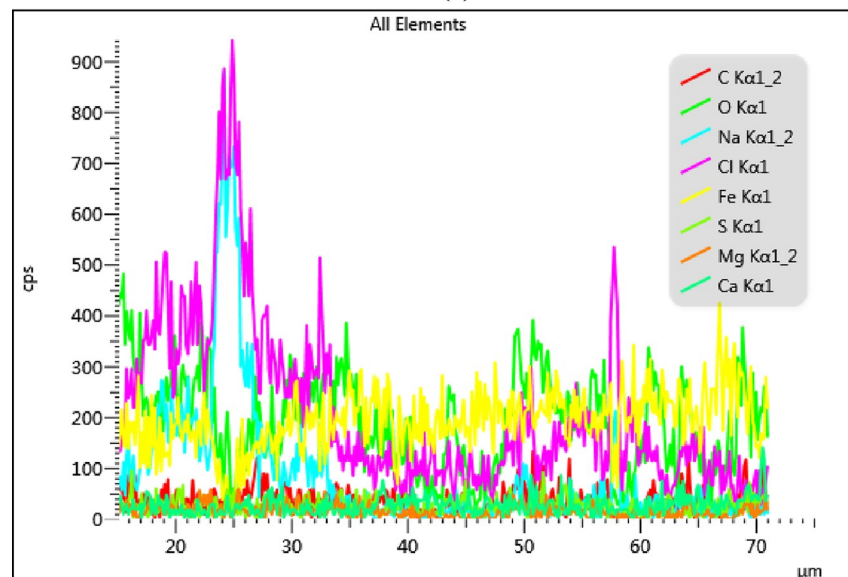
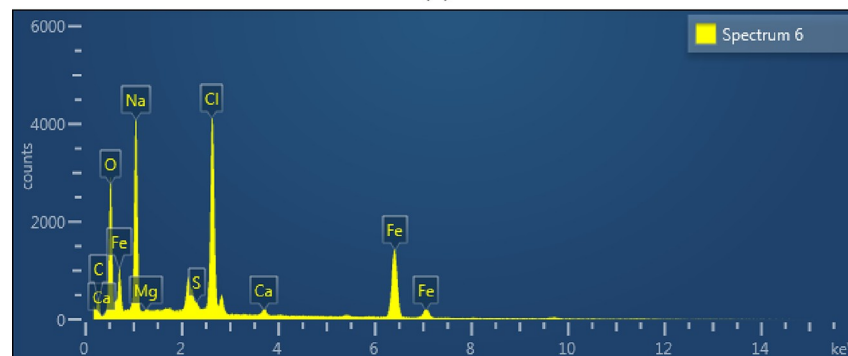
Fig 8. The micro morphology of sample surface and EDS region energy spectrum analysis diagram after WM corrosion. (a) Surface micro corrosion morphology, (b) Line scan of corrosion product elements on the surface and (c) Distribution of corrosion products on the surface.

similar, mainly composed of C, O, Fe, Na, Mg, Cl and Ca. according to the element content analysis of the surface, the content of C, O and Fe accounted for the most, and it can be concluded that the corrosion products were mainly C, O and Fe. While the other elements could possibly be the electrolytes which were stuck to the surface of the sample, instead of completely dissolved in the corrosion solution. Therefore, it can be determined that the corrosion products were the oxides of FeCO₃ and iron. The formation of FeCO₃ was due to that the CO₂ gas dissolved in water to form carbonic acid, and then react with the Fe in the material to form FeCO₃. While the oxides of iron might be formed by the oxidation of the corroded sample when exposed to air. Besides, the CL content level on WM surface was almost twice of that on BM. The main reason was that the WM surface was rough, with defects such as inclusions and stress concentration, which led to the fact that the passivation film of WM was not as stable as BM's. The penetration ability of Cl⁻ in the corrosion solution was strong, and it was easier to be absorbed by WM surface, which undermined the stability of the corrosion product film, thus accelerating WM corrosion.

S8 Fig. The micro morphology of sample surface and EDS region energy spectrum analysis diagram after WM corrosion. (a) Surface micro corrosion morphology, (b) Line scan of corrosion product elements on the surface and (c) Distribution of corrosion products on the surface.

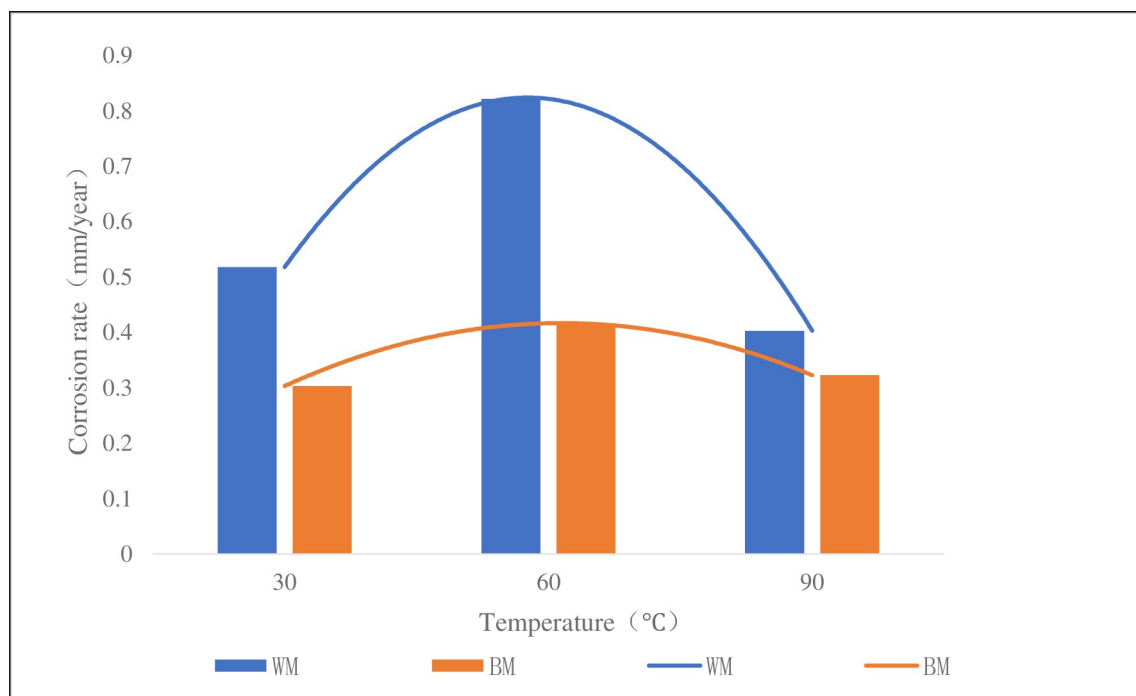
Fig 9. CT110 corrosion rate at different temperatures.

Fig 9 was a column chart of corrosion rate of the samples at different temperatures with CO₂ partial pressure of 0.3 MPa, total pressure of 4 MPa, solution pH of 5.6. It can be seen from the figure that the corrosion rate of the weld at 30°C, 60°C and 90°C was 1.7, 2.0 and 1.2 times of that of the base metal, respectively. At 60°C, the corrosion rate was larger, showing a trend of increasing first and then decreasing. According to the principle of electrochemistry, the corrosion rate increases with the increase of temperature, when it reaches a certain peak value, the product formed by the corrosion reaction on the surface of the sample forms a dense protective film, thus hindering the occurrence of the corrosion reaction and reducing the corrosion rate. Through the comparison of the corrosion rate of base metal and weld metal, it can be

seen that the corrosion rate of weld metal was higher than that of base metal at different temperature, which indicated that the weld was more susceptible to corrosion. The main reason was that during the welding process, the structure of the weld was not uniform, there was a certain residual stress after welding, and there were also some defects such as inclusions and dislocations [26], which caused the lattice distortion energy at the weld boundary, the activity to increase and the electrode potential to decrease, to create a potential difference between the weld and the base metal, and a galvanic cell will be formed this way to accelerate into a more severe corrosion on WM material.

S9 Fig. CT110 corrosion rate at different temperatures.

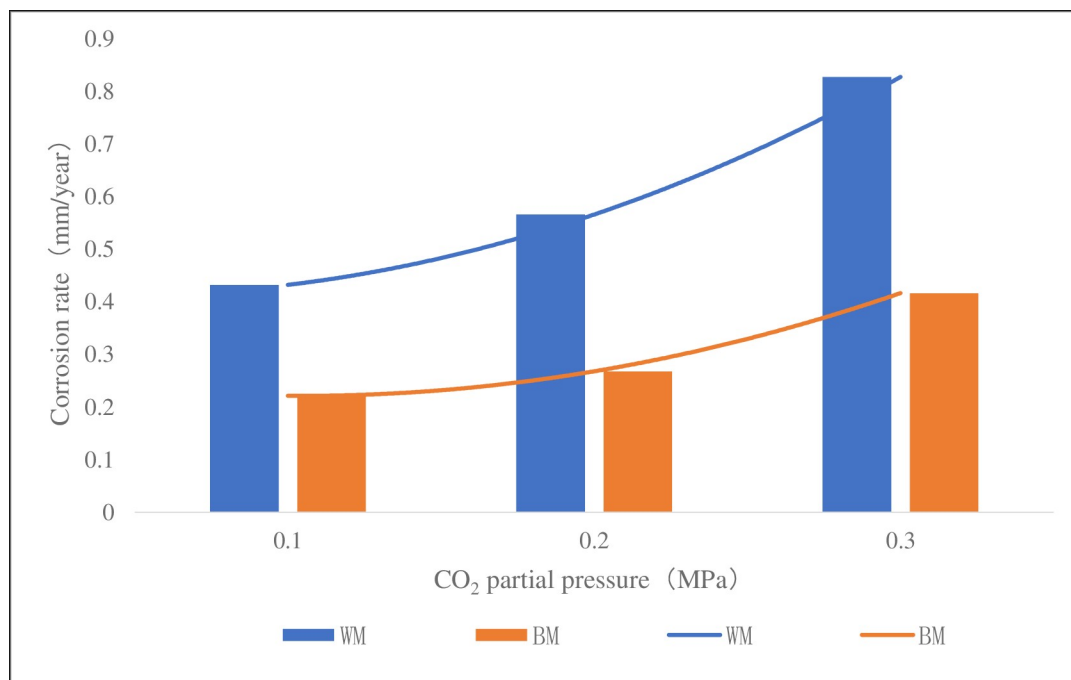
Fig 10. CT110 corrosion rate at different CO₂ partial pressure.

Fig 10 was a column chart of corrosion rate of the sample at 60°C, 4 MPa, pH 5.6 and different CO₂ partial pressure. It can be seen from the figure that the corrosion rate of WM at 0.1MPa, 0.2MPa and 0.3MPa was 2.0, 2.1 and 2.0 times of BM's respectively, but the corrosion rate of WM and BM increased with the increase of CO₂ partial pressure. It could be well explained from the principle of electrochemistry and the diffusion principle of substance. When the partial pressure of CO₂ in the solution increases, the diffusion rate of CO₂ molecules in the solution will increase accordingly to accelerate the reaction of the cathode, then both the concentration

of carbonic acid generated and the concentration of H^+ ionized will increase, which will further increase the dissolving activities of the metal iron at the anode and the general corrosion rate. It can also be concluded that the corrosion rate of WM is higher than that of BM at different CO_2 partial pressure, which further proves that WM is more susceptible to corrosion.

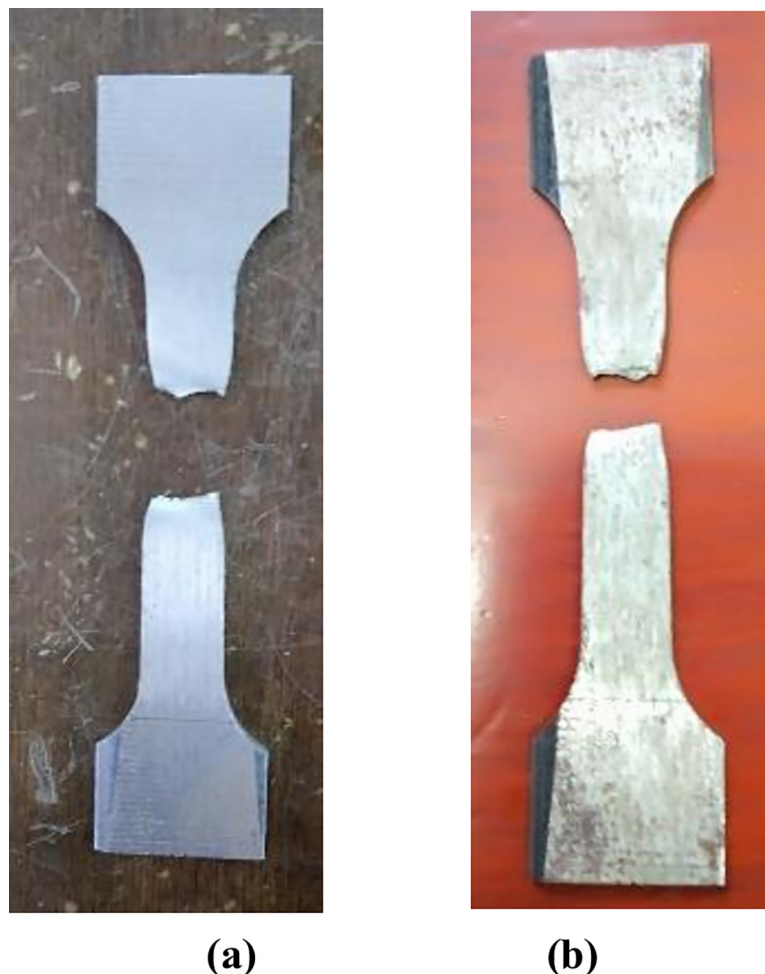
Fig 11. Fracture morphology of sample after tensile test. (a) Before corrosion and (b) After corrosion.

It can be seen from Fig 11 that there were many dimples on the fracture surface of the sample before corrosion and the sample showed pretty good ductility. While the fracture surface of the sample after corrosion was relatively flat and tends to brittle fracture. Fig 12 showed the yield strength, tensile strength and elongation at break of the WM and BM before and after corrosion. Table 4 shows that the yield strength and tensile strength of CT110 weld were reduced by 4.8% and 8.2% respectively. The yield strength and tensile strength of CT110 base metal reduced by 4.0% and 7.1%, respectively. From the comparison of the above data, it can be concluded that corrosion undermined the mechanical properties of CT110, and showed a greater impact on the mechanical properties of the weld.

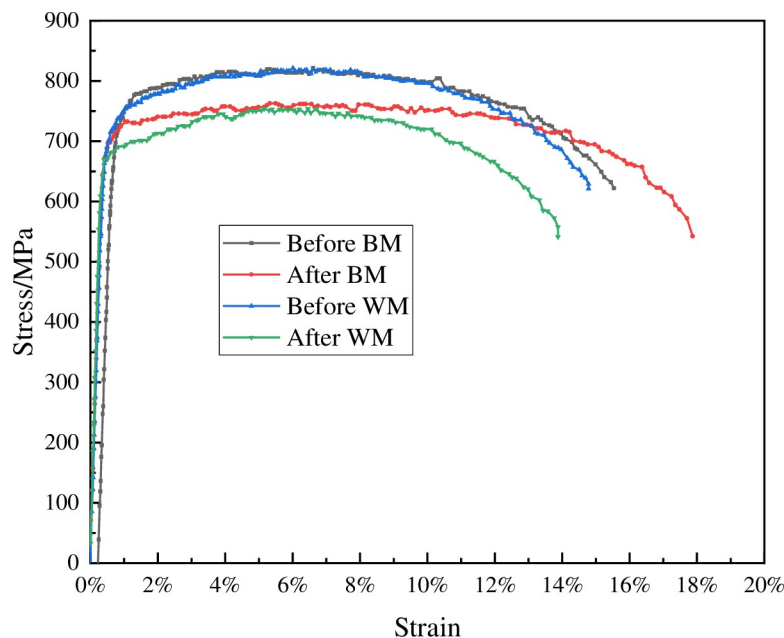
Fig 12. CT110 WM and BM stress-strain curve before and after corrosion.
